ASSESSMENT OF THE RE-HABILITATION OF THE SEABED FOLLOWING MARINE AGGREGATE EXTRACTION

by S. E. Boyd¹, D. S. Limpenny¹, R. Kilbride¹, K. M. Cooper¹ and W. Meadows²

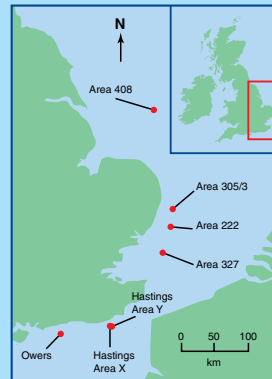
Figure 1: Exploratory sites sampled in 2000

Exploratory studies in 2000 identified seven locations considered representative of dredging practices and habitats in UK waters (Figure 1). Each varies in the time-interval since cessation of dredging and therefore has the potential to represent different stages in the 'recovery' process. More comprehensive surveys were conducted in 2001 and 2002 at Area 408 (Humber), Area 222 (Thames), and Hastings Areas X and Y.

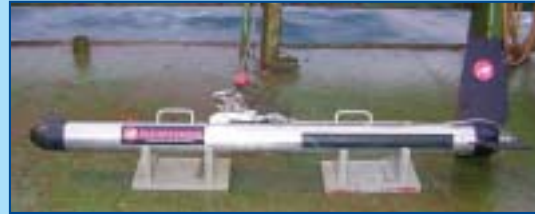
Figure 3: Digital sidescan sonar towfish

Intensive sidescan surveys covering 100% of the seabed using a digital chirps sidescan sonar system (Figure 3) are carried out annually, with post processing software being used to mosaic the sidescan tracks (Figure 4). An acoustic ground discrimination system (AGDS) is also being employed to assist in the description of the substrata.

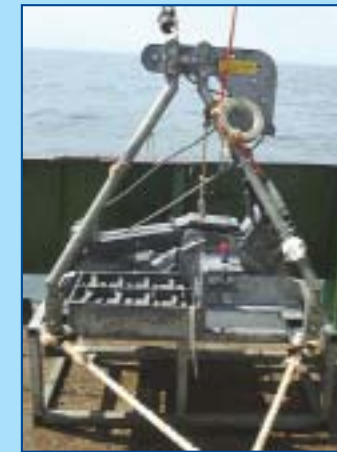
Figure 5: Hamon grab mounted with video and lights with an example of macrofauna and a typical grab sample

At each extraction site, a 0.1m² Hamon grab fitted with an underwater video camera and light (Figure 5) is being used to sample the biological communities and sediments from each of the three treatment groups. In addition, sampling of the epifauna is being carried out using a 2m heavy duty beam trawl (Figure 6), and video footage from across the survey area is being collected using a drop camera frame mounted with video camera and lights.

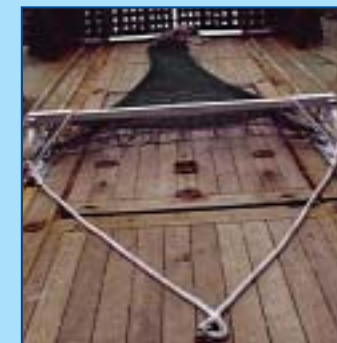
Figure 6: Heavy duty 2m beam trawl with examples of beam trawl samples collected from an area of high dredging intensity and a reference location
